**Our Lady of Fatima RCC,
802-464-7329
www.ourladyoffatima.vermontcatholic.org
olfwil@vermontcatholic.org
P.O. Box 188
96 E. Main Street
Wilmington, VT**

Windows Project

- Purpose: To investigate all options in regards to repair / replacement of the large “stained glass” windows and the lower venting windows.
- Present state:

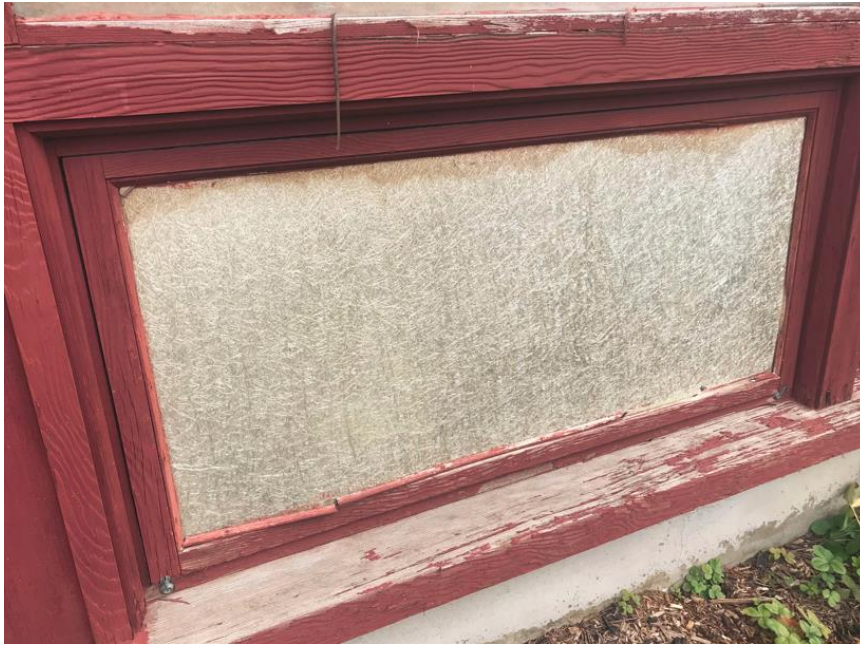
Exhibit A

- **Exhibit A:** The lower venting windows installed in 1964 must be replaced. Many are no longer operable due to the dry rot and failing mechanisms. Many have had broken glass over the years due to the warpage and sun damage. There is no longer any thermal value and most of them no longer close completely. Our handyman attempts to close these securely each fall to reduce heat loss. There are 16 of these venting windows that need immediate attention.

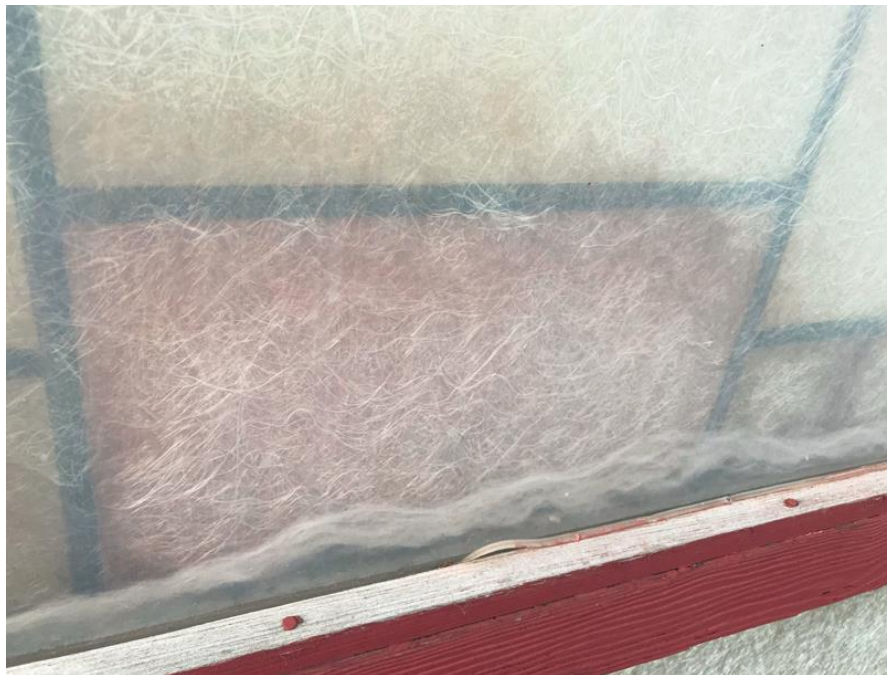
Exhibit B

- **Exhibit B:** The exterior of the fiberglass windows has severe “fiber blooming” taking place due to sun damage. The glass resin has completely deteriorated thus exposing the fibers.

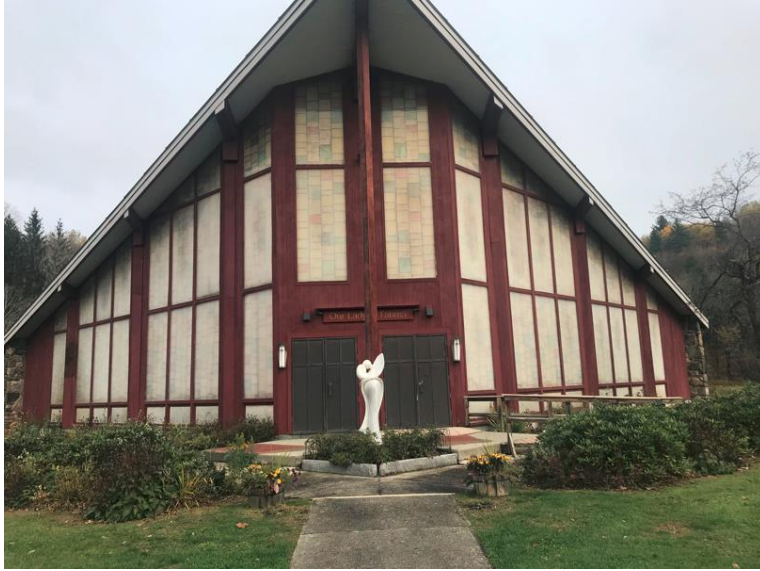
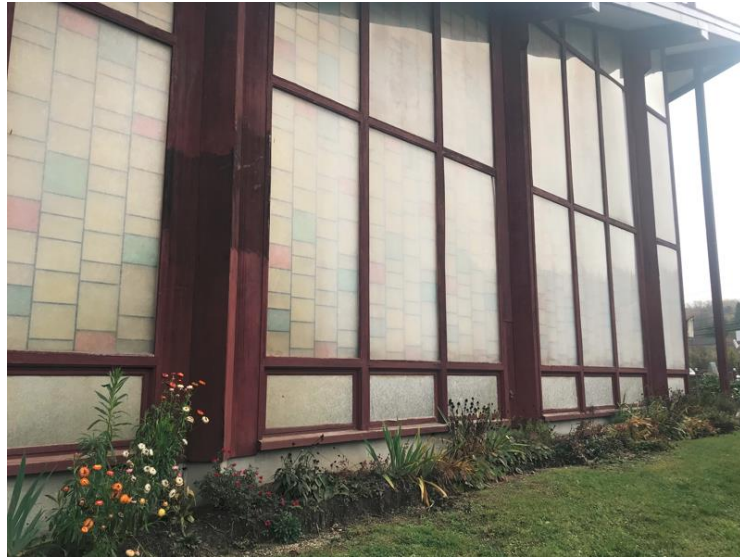
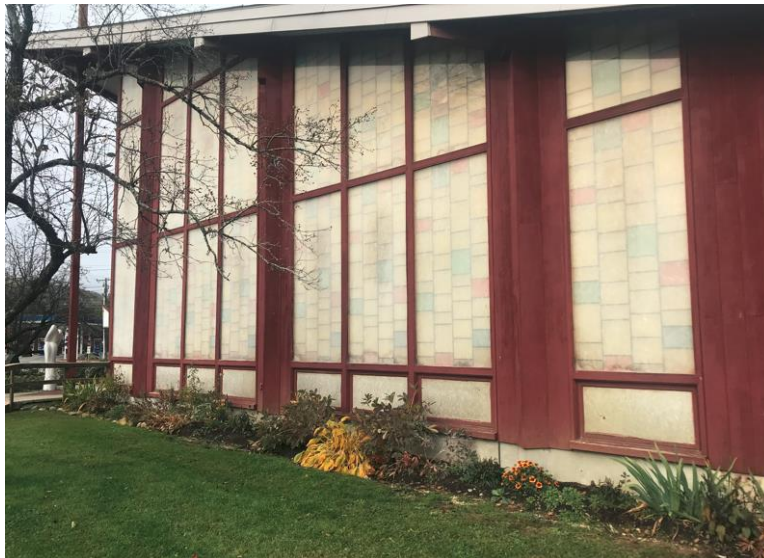
Exhibit C

- **Exhibit C:** These “stained glass” windows were installed in 1964. They are “Kalwall System” windows, a colored fiberglass resin with a fiber sandwiched in-between the interior and exterior panels. At some point, a 3rd layer of clear polycarbonate was installed to add a protective layer and thermal barrier. This barrier has become severely yellowed, cloudy, and ineffective.

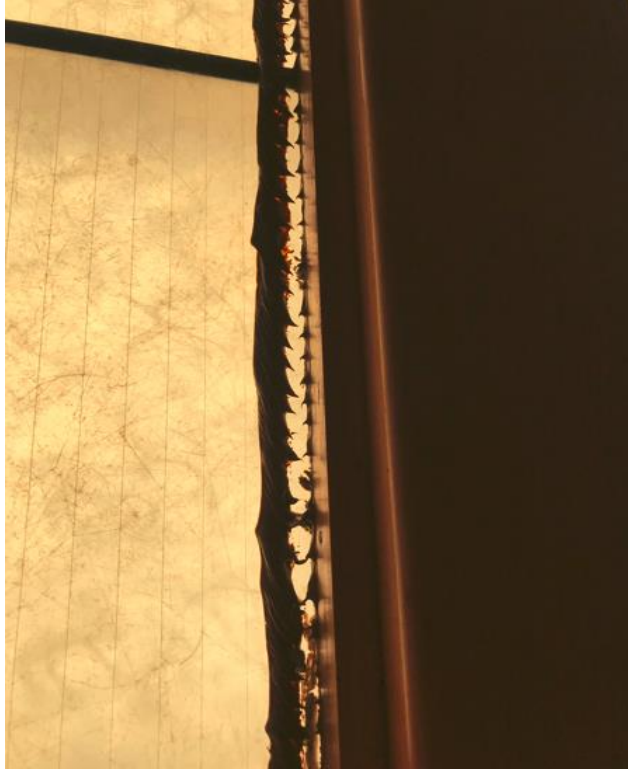
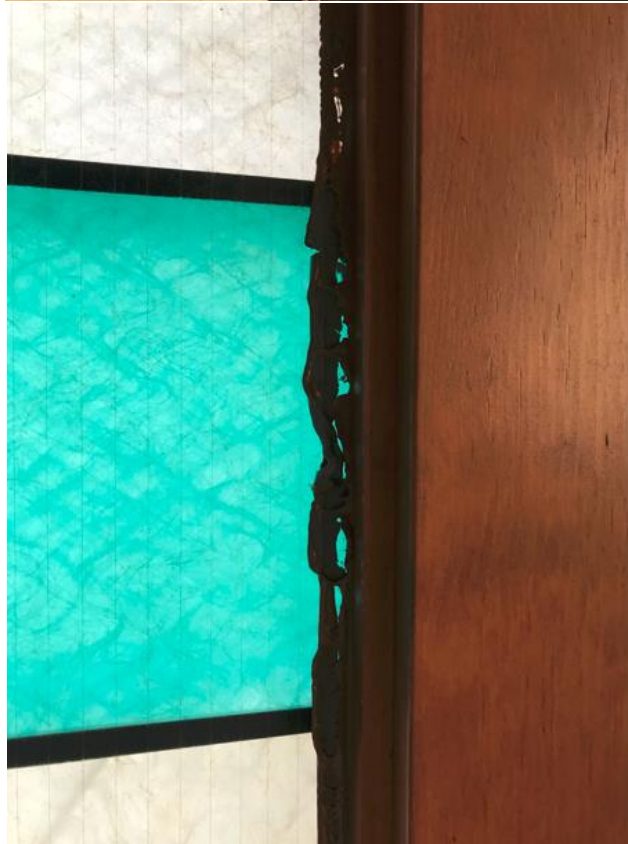
Exhibit D

- **Exhibit D:** The fiberglass windows have been caulked and re-caulked on the interior to fill in the gaps created by expansion and contraction. Presently, we have gaps showing to the exterior.

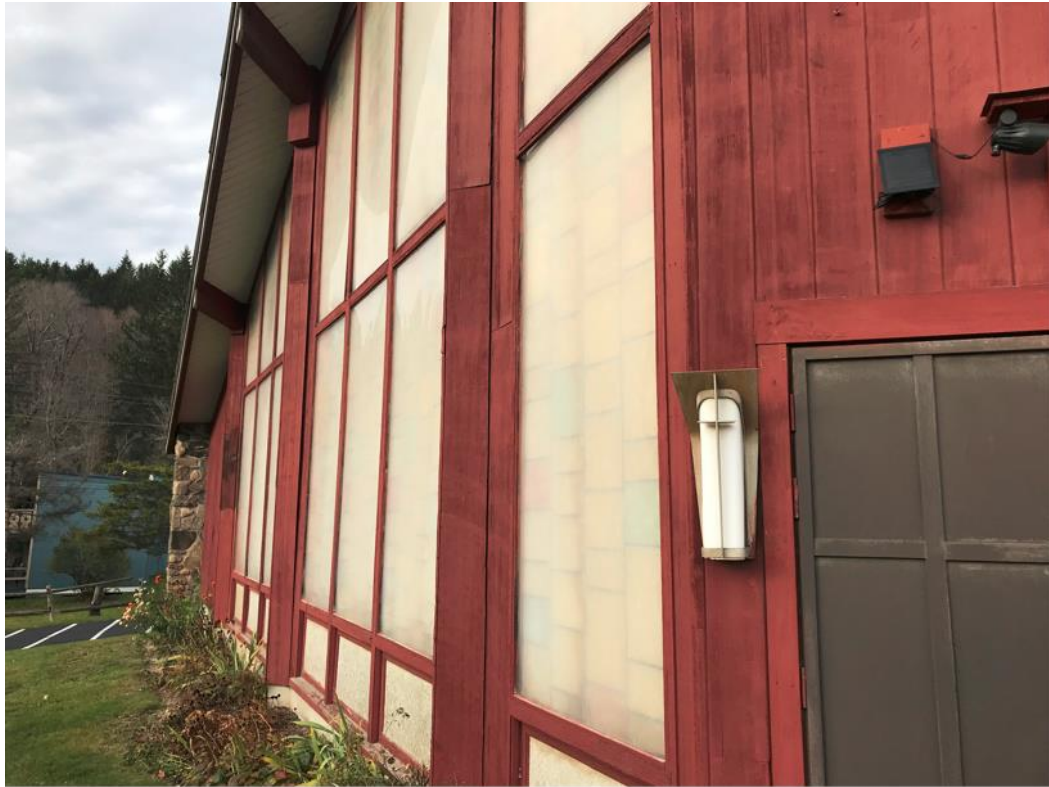
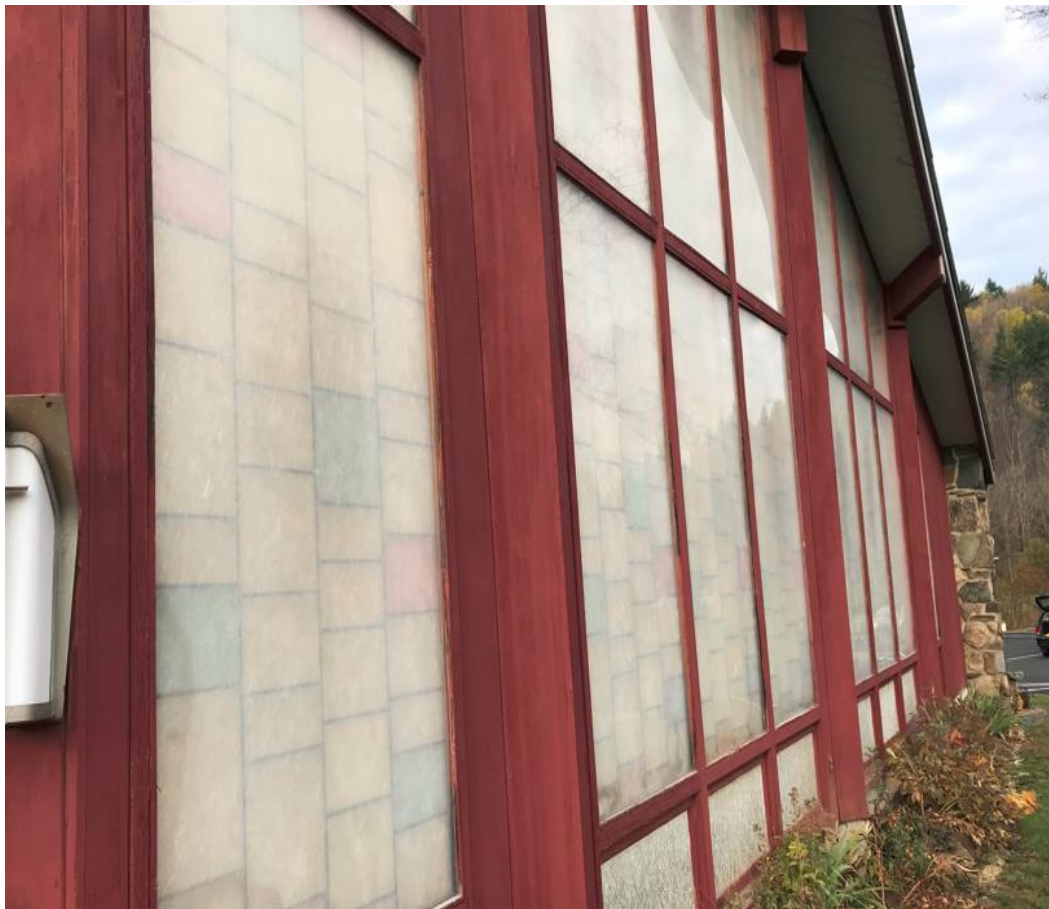
Exhibit E

- **Exhibit E:** The exterior of the fiberglass windows that is exposed to the sun’s rays have faded and lost nearly all color due to the UV rays breaking down the pigment in the fiberglass.
