**Our Lady of Fatima RCC,
802-464-7329
www.ourladyoffatima.vermontcatholic.org
olfwil@vermontcatholic.org
P.O. Box 188
96 E. Main Street
Wilmington, VT**

Windows Project

- Purpose: To investigate all options in regards to repair / replacement of the large “stained glass” windows and the lower venting windows.
- Present state:

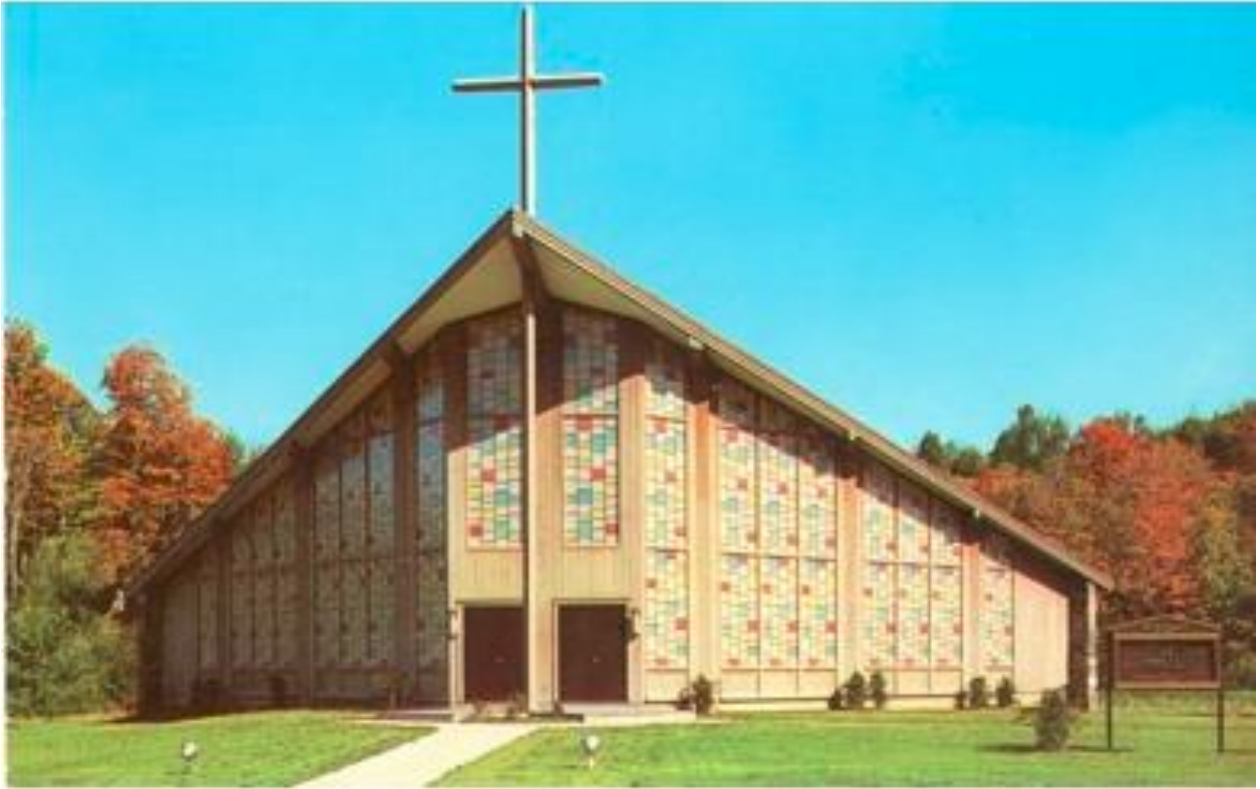
Exhibit F

- **Exhibit F:** Our Lady of Fatima back in the day! How we want to look after this project is completed. Colorful, vibrant, and welcoming.
 - Some of the fiberglass window sections shake on windy days due to the framing and trim deteriorating.
